February 2025

No. 372

Working Party News

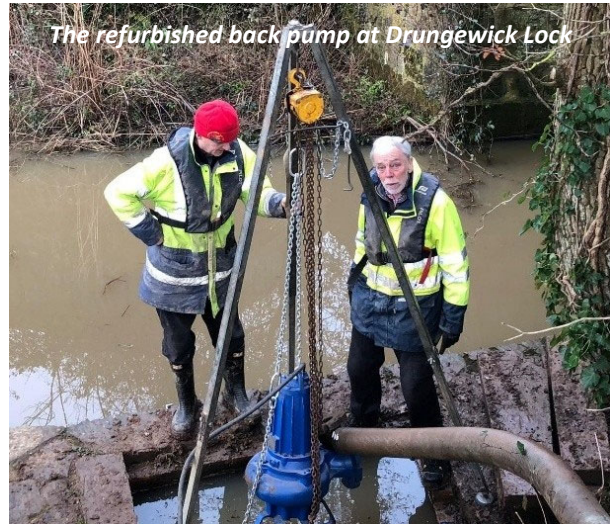
The refurbished back pump at Drungewick Lock

In preparation for a metal storage cabinet to be placed at Drungewick Slipway, we cleared the ground and put in a concrete base between the picnic bench and boundary hedge. We also assisted the contractors with reinstalling the serviced river pump and a refurbished back pump at Drungewick Lock. With the back pump now in working order, we have finally been able to fill the pipe trench and leave the site tidy.

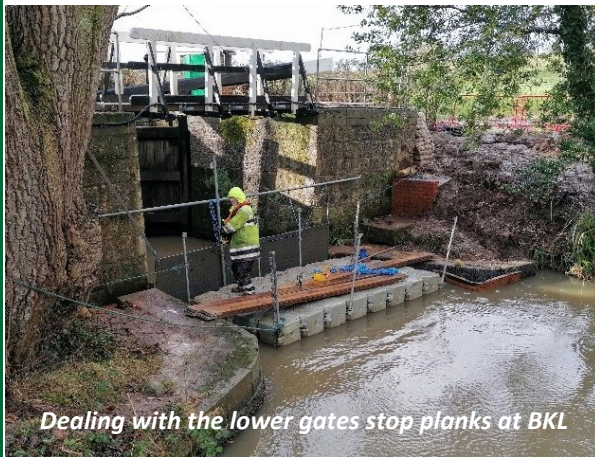
Dealing with the lower gates stop planks at BKL

Having successfully tackled the leaking stop planks by the top gates of Baldwin's Knob Lock, we returned to work on the stop planks for the lower gates. With the aid of the aqua-dock, we braved heavy rain to place ground protection mats and a tarpaulin in front of the planks to reduce leakage. The stop planks have been installed so that the lock chamber can be pumped out for a structural inspection to take place.

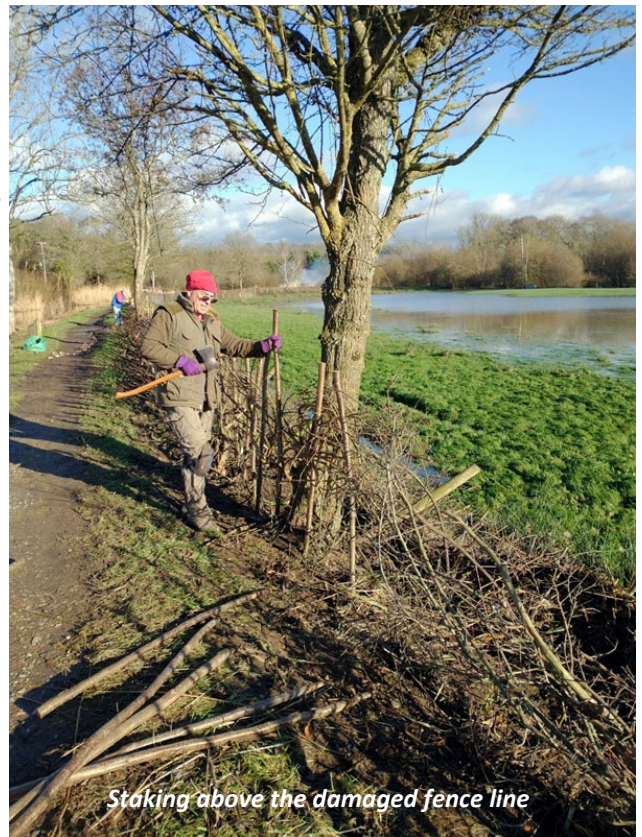
Apart from interfering with actual work, the heavy rains have led to various problems. Parts of the current hedge at Drungewick have been severely flooded by the canal over-topping. There is a spillway along the towpath where we are working, but this seems to be set too high, or more probably, maybe not wide enough to cope with the excess flows that we seem to experience every winter now. The canal overtops elsewhere on both banks around the Drungewick Slipway and has deposited large amounts of flotsam (especially cut reeds) into the hedge and also importantly into the stock-fence on the edge of the field below it.

The flooding has knocked over the fence in places, and many of the fence uprights have rotted. A 130m section of stock fence (exactly adjacent to the length we laid in 2023/24) was apparently replaced in summer 2024 by Dave Evans, but that has already collected wet detritus in places and its life is most certainly reduced. Unfortunately, there is a further 270m of old fencing, adjacent to the hedge where we are working now, which has also collected detritus. It has been knocked over in part and so is no longer stock-proof. The laid hedge should act as an animal barrier, but in parts the hedge does not exist, and the farm manager thinks that out of control dogs will still find access points into the field. So the fence will need replacing.

Staking above the damaged fence line

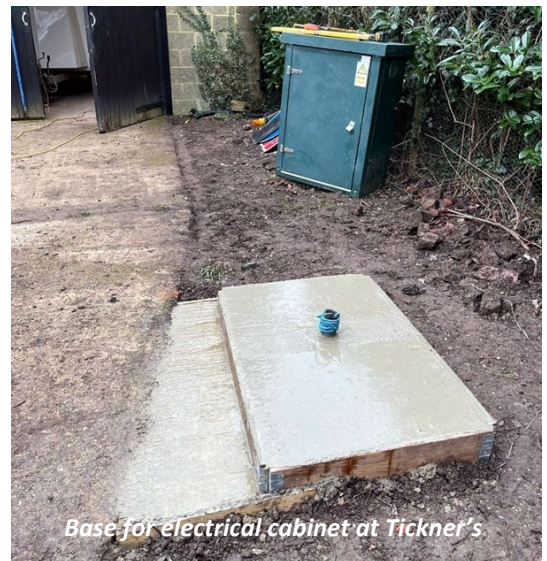
Base for electrical cabinet at Tickner's

We then had a day at Tickner's Depot, where we installed underground power cable ducting and a concrete base for a cabinet between the MDV Shed and the Machine Shop. This is to facilitate a convenient external power socket to be available for vehicle maintenance etc. We also refitted the main water supply stopcock cover at the corner of the log bays after it had been inadvertently dislodged during groundworks.

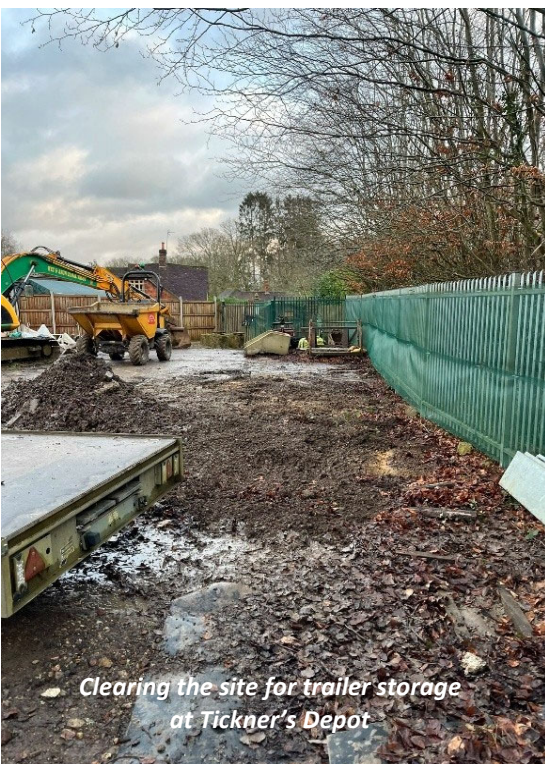
Clearing the site for trailer storage at Tickner's Depot

A new hard standing is to be installed at Tickner's Depot as a parking area for the Trust's trailers. We cleared the equipment and debris from the area at the bottom of the yard and began to excavate the plot for the sub base and concrete to be laid.

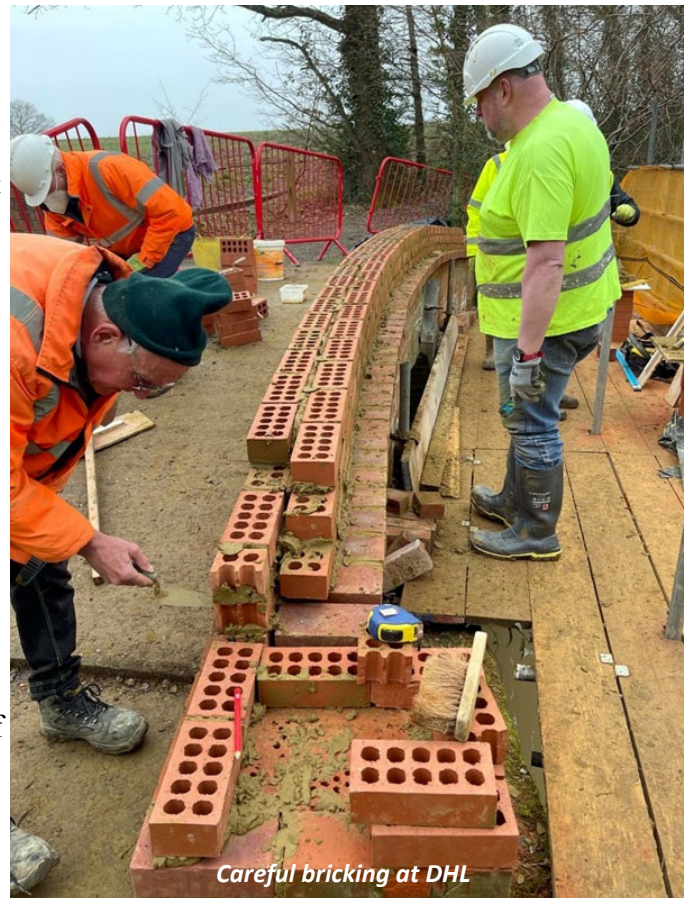
The south side, however, was so badly cracked and with a large number of the bricks having spalled faces, that it was beyond repair. After demolishing the wall down to the bridge deck level, the group set to rebuilding the wall. Unlike normal brickwork with level horizontal joints and straight on plan, the new brick wall is curved both on plan and in elevation. This required a considerable amount of setting out and with timber curved profiles having to be made to ensure the brickwork maintains the correct curves.

In addition to the complexity of the wall layout it is necessary to lay steel "ladder" type reinforcement every fourth course to ensure the future stability of the wall. Because of the original method of construction of the supporting stone bridge abutments, it is inevitable that they will continue to "move" with the seasonal expansion and contraction of the clay ground on which they were built. Hopefully the reinforcing to the parapet wall will keep movement to a minimum.
