For WACT Volunteers

No. 375

Working Party News

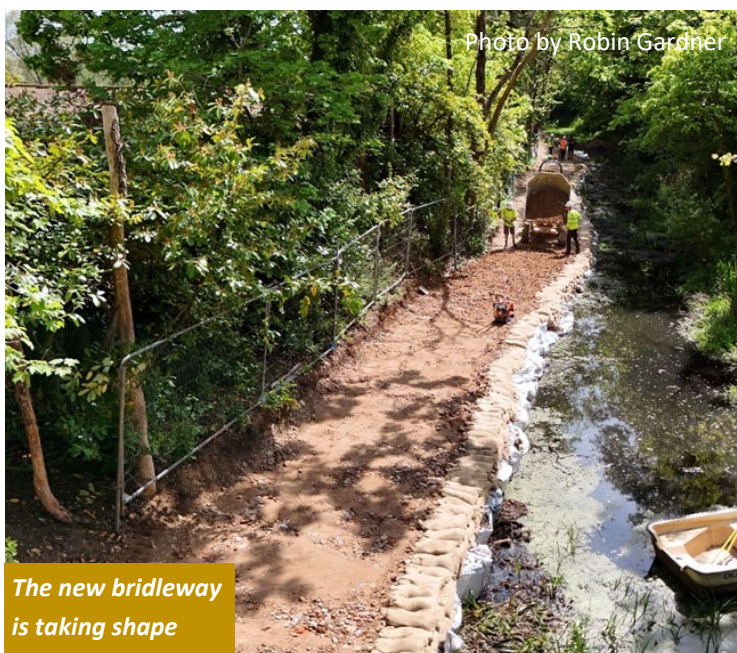
The new bridleway is taking shape

The Group is continuing with the construction of a new bridleway at Rye Farm. Early morning each work day, we take delivery of dry mixed concrete which is discharged into bulk bags plus an additional heap used for filling sandbags. Later in the day we have deliveries of bulk bags of crushed concrete and a load of hard core.

We now have an efficient routine for construction of the bridleway. To start two bags of dry mix concrete are carefully positioned in the canal maintaining the correct line. These are fixed securely in place by sinking scaffold poles through the bags into the canal bed. Then two bags of crushed concrete are placed alongside the dry mix bags. Spoil is then spread between the bags and the bank and then covered with geogrid matting before hard core is spread on top. Then we move forward and repeat.

Each day we place ten bags of dry mix concrete and ten bags of crushed concrete, so that we complete 20 metres each week. Meanwhile, sandbags are filled with dry mix and placed on the canal side of the path. So far, we have completed over 120m of the base surface of the bridleway.

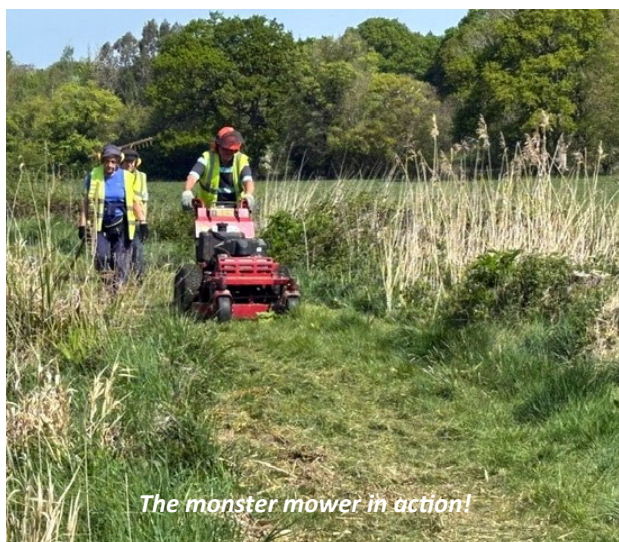
The monster mower in action!

In late April, with the use of the 'monster mower', we were able to 'do a proper job' cutting the towpath from Drungewick Bridge to the lock, around the lock and winding hole. A satisfactory outcome!

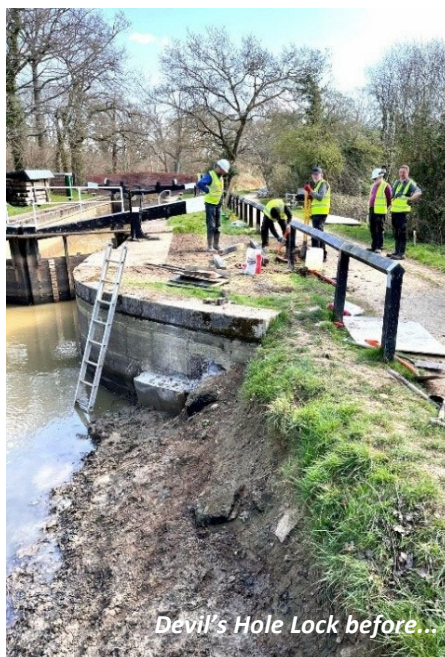
Devil's Hole Lock before...

This month we began by returning to Devil's Hole Lock to continue dealing with the leak that caused the sink hole by the top lock gates. We removed the shuttering from the concrete repair, backfilled the sink hole and replaced the post and rail fencing that had been removed to enable access by an excavator. Several trips were then made to Ewhurst Brickworks to collect loads of clay that they had kindly donated, to pack the canal bank and complete the repair.

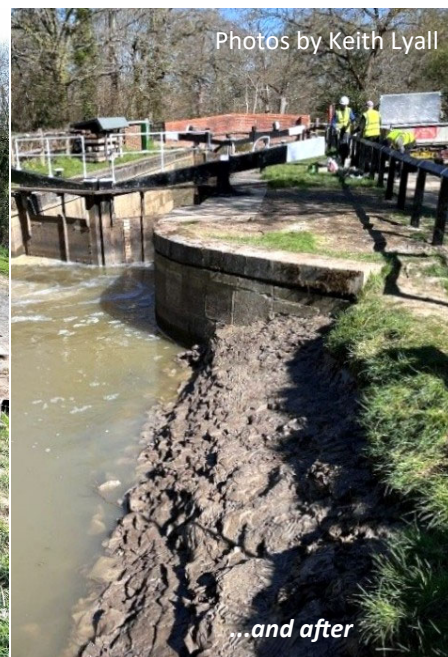
...and after

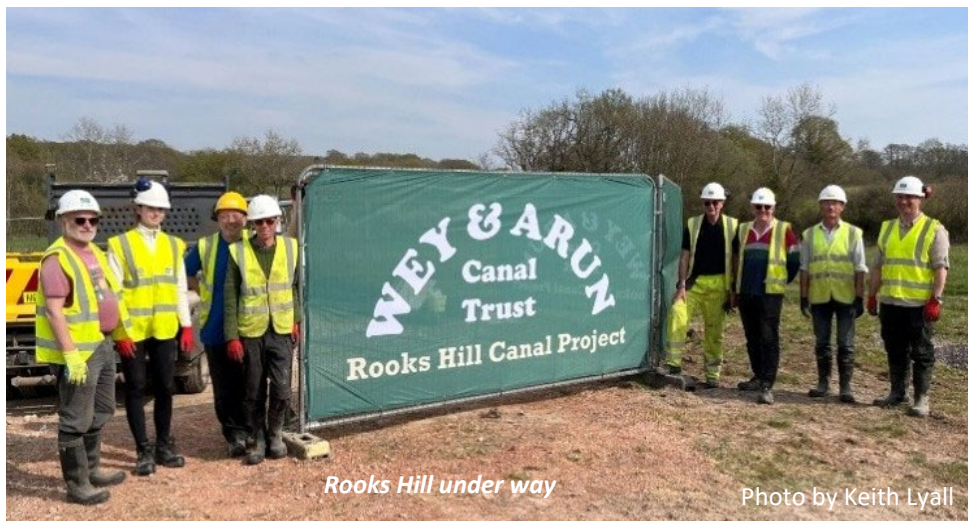
Rooks Hill under way

We then had several weeks erecting tree protection fencing along the site boundary of the Rooks Hill Project site. The fencing is required by the local authority as part of the planning consent for the new bridge and new section of canal.

Following the visit of the Newbury Working Party Group who made a good start with the fencing and compound, we completed approximately a further 120 metres in several weeks, just in time for a planned visit from the Local Authority's Tree Officer to inspect the final works.

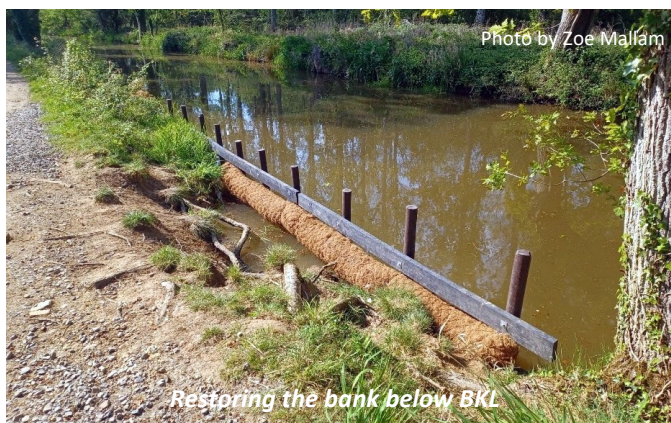
The canal bank by the towpath just downstream from Baldwin's Knob Lock had become badly eroded, so we assisted Zoe by taking *May Upton* to the site and installing post and rail formwork, to support coir rolls for a re-profiled edge. We now intend to backfill the void between the canal and towpath.

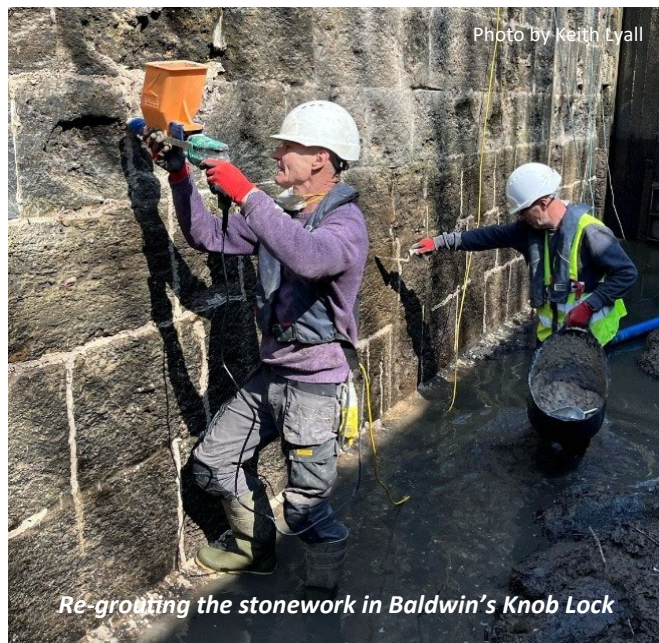
Re-grouting the stonework in Baldwin's Knob Lock

All of the joints in the lock stonework, up to the low

level water line, have been raked out and grouted, with the assistance of a motorised mortar gun. We removed both sets of stop planks at the upper and lower gates to enable us to use *May Upton* inside the lock to re-grout the higher levels of blockwork.
